THE USE OF RADIOMETRIC PARTIAL DISCHARGE LOCATION EQUIPMENT IN DISTRIBUTION SUBSTATIONS

This paper explains the application of the locator to distribution substations. It describes the method of use and the added difficulties of radiometric PD location at lower voltage levels. The paper presents and analyses the results obtained from site trials in a 33 kV substation which revealed PD in the vicinity of an air break isolator.

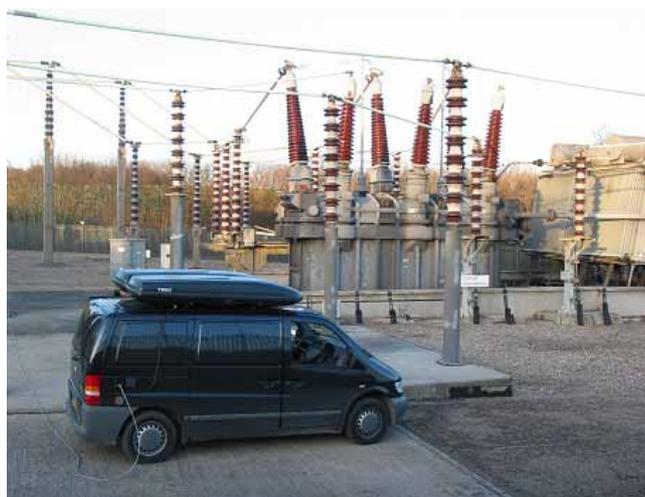
Figure 1. Photograph of the van during recording process

The measurement system is based on the synchronous acquisition of four channels of radio frequency (RF) radiation. Four wideband, disk-cone type antennas are mounted on the roof of the vehicle inside two separate plastic roof boxes creating a rectangular array of approximately 1.5m

All metallic parts of the van are electrically bonded to a common point that can be connected to a safety earth connector. This prevents the build-up of static charge allowing prolonged measurements to be taken within a substation if required. The oscilloscope can be supplied from an external supply if the vehicle is stationary, or through the use of a battery-fed inverter, allowing measurements whilst the vehicle is mobile. The battery is charged from the vehicle alternator. To reduce unwanted rf impulsive noise the vehicle is powered by a diesel engine. A photograph of the vehicle whilst in the process of monitoring is shown in Figure 1 below.

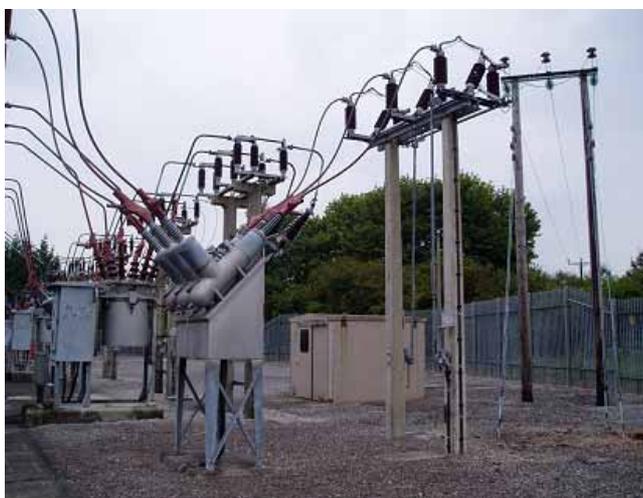
Figure 9. Side photograph of the ABI, VCB and substation building
